Wind Turbine Foundation – Durable buildings are needed

- Foundation Damage -

8.2 Ingenieurgesellschaft Timo Poetschke – Münster mbH - Germany -

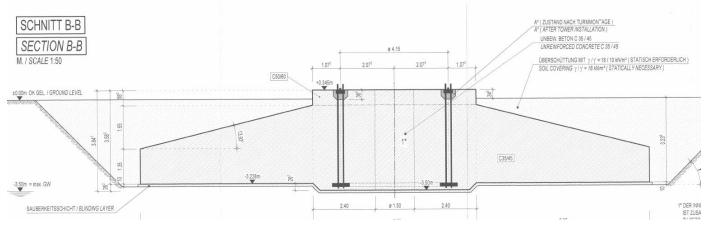
Wind turbine foundation

The most used types of tower interface...

>> Foundation section Schnitt

Anchor cage

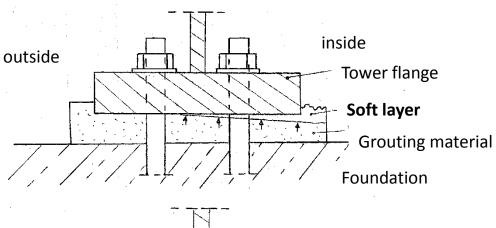
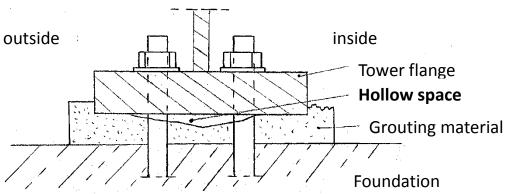
Anchor cage

Grouting joints

Reduced load transfer surface

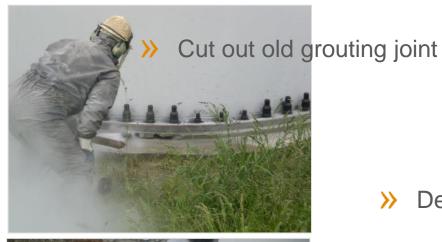
Anchor cage

Remedial action:

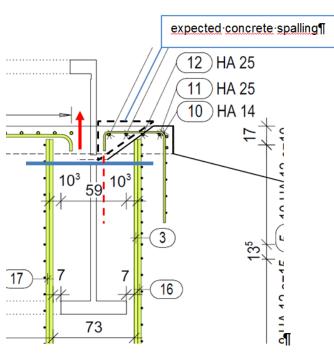
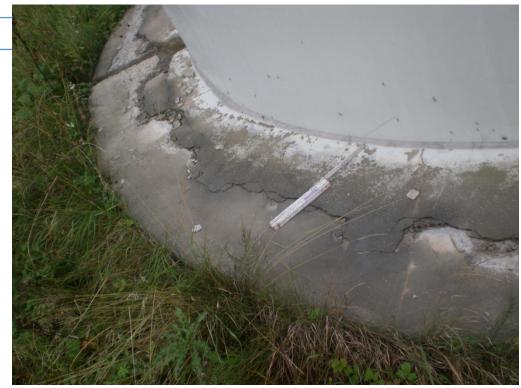
Foundation section - Decoupling

Decoupling needed

Elastic elongation of steel

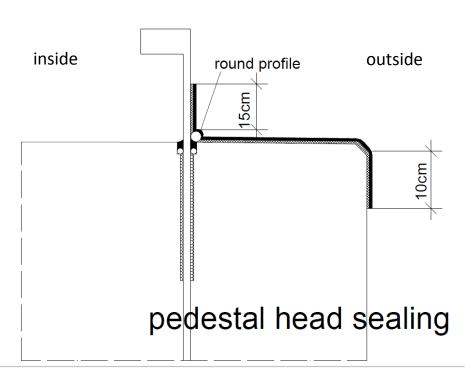
Foundation section - Waterproofing

Waterproofing the gap between concrete and tower

>> Use a belt as well as additional suspenders!

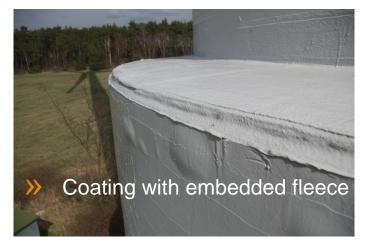
Foundation section - Waterproofing

Remedial action: belt + suspenders

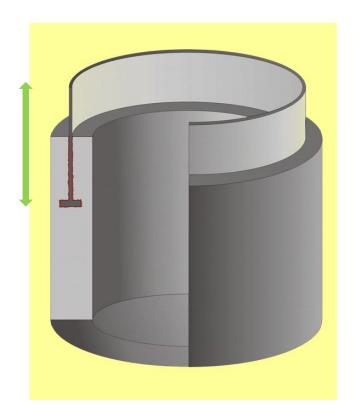
Foundation section - unfixed

Loose tower fixation

>> Water destroys the tower fixation

Analysis by measurement of vertical tower movement.

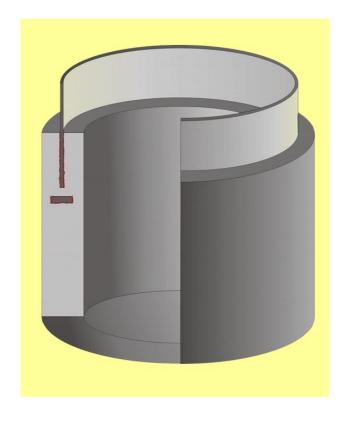
Causes for moving are:

Broken weld seam or steel plate

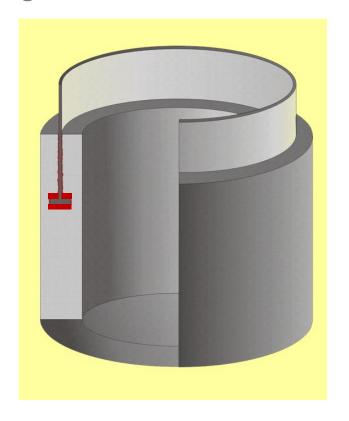
Gap in form closed fixation

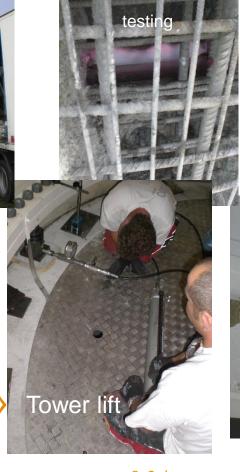
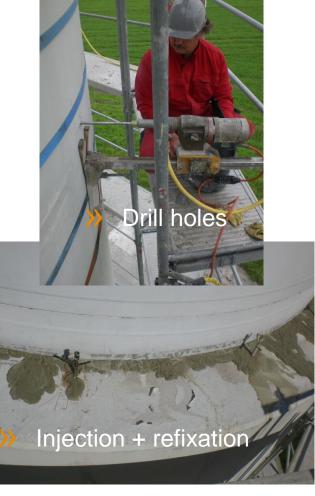
Foundation section - refixation

Remedial action:

Weld seam

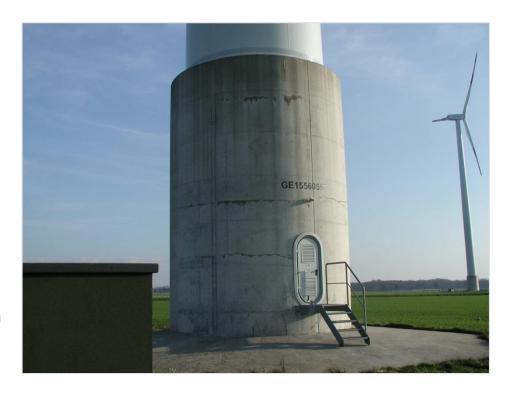
Reinforced concrete

Cracks in foundation pedestal

>> Work-sharing between concrete and reinforcement

Concrete = compressive force

Reinforcement = tractive force

Cracks in concrete show activated reinforcement

Water entrance will become a problem with durability for the building!

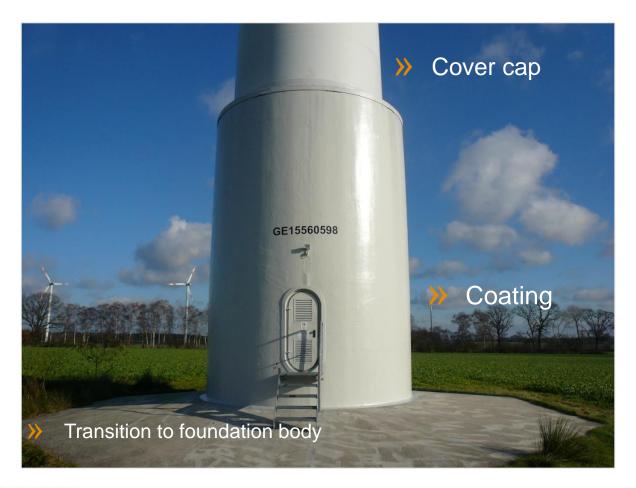
Reinforced concrete

Remedial action:
